Case study from Peterborough City Council

Example premise

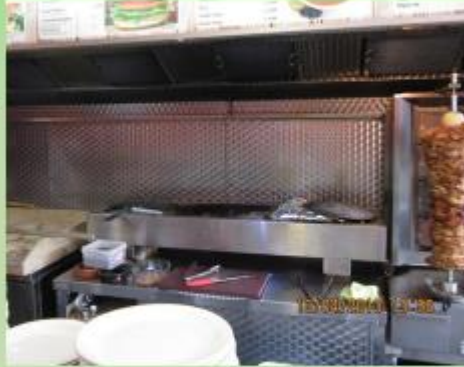
- New premise with charcoal grill
- Grill and extraction custom made, supplied and fitted by same company
- Initial visit made and questionnaire completed
- Datalogger placed
- Datalogger results show significant CO levels, at times over 500ppm
- No accommodation above

- IN served for substitution or COSHH assessment and appropriate controls
- **Charcoal put out at night** before extraction turned off
- Changes made to extraction to improve efficiency at grill
- Optimum settings determined for extraction, then staff **DO NOT TOUCH**
- Cleaning programme introduced for extraction/ventilation
- Changed grade of charcoal being used? (Debatable value!)
- CO alarm fitted
